Manhole Inspection Summary

Manhole # S15MM1026MH

Insp Date: **5/28/08 12:04 PM**

Location Address: **GREENSPRING AVE**

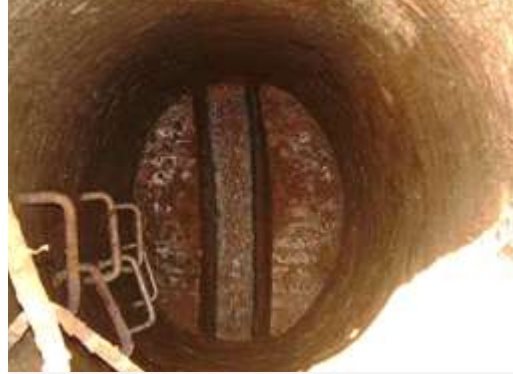
Top View

Corroded steps. Evidence of surcharge - Bench debris.

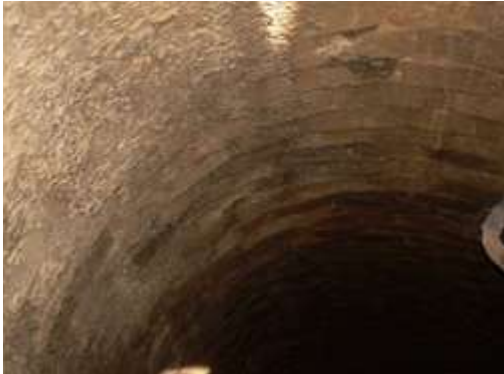
Defect

Barrel infiltration.

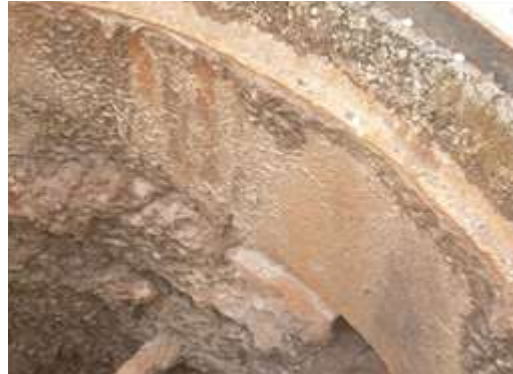
Defect

Frame leaks. Adjustment deterioration and infiltration.

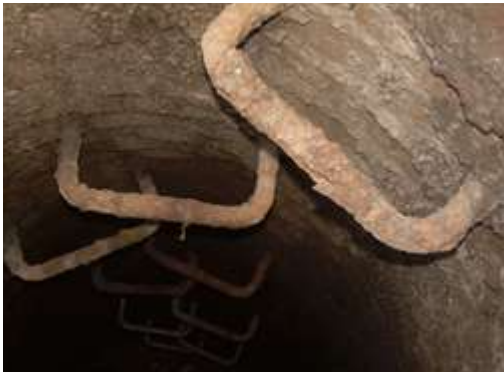
Defect

Barrel infiltration.

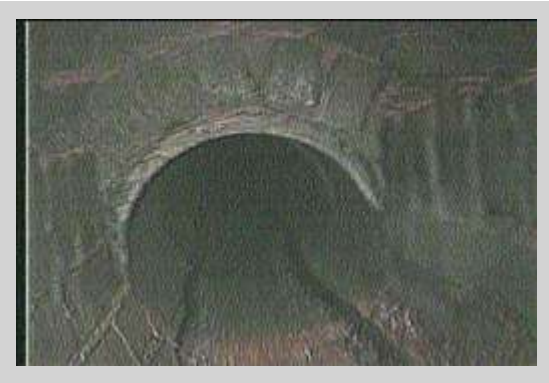
12 in. Circular Gravity Sewer Pipe Out @ 12 O'Clock

Infiltration: **Evidence** Pipe Seal Cond: **Cracked**

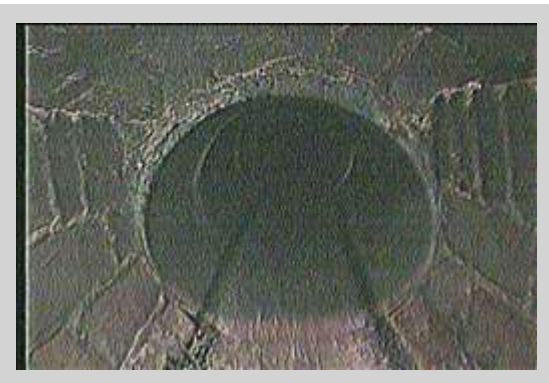
12 in. Circular Gravity Sewer Pipe In @ 6 O'Clock

Infiltration: **None** Pipe Seal Cond: **Cracked**
